**International Road Tunnel Fire Detection  
Research Project – Phase II**

**Task 4: Field Fire Tests on Performance of Fire Detection  
Systems in an Operating Road Tunnel in Montreal**

National Research Council of Canada

© July 2008 Fire Protection Research Foundation

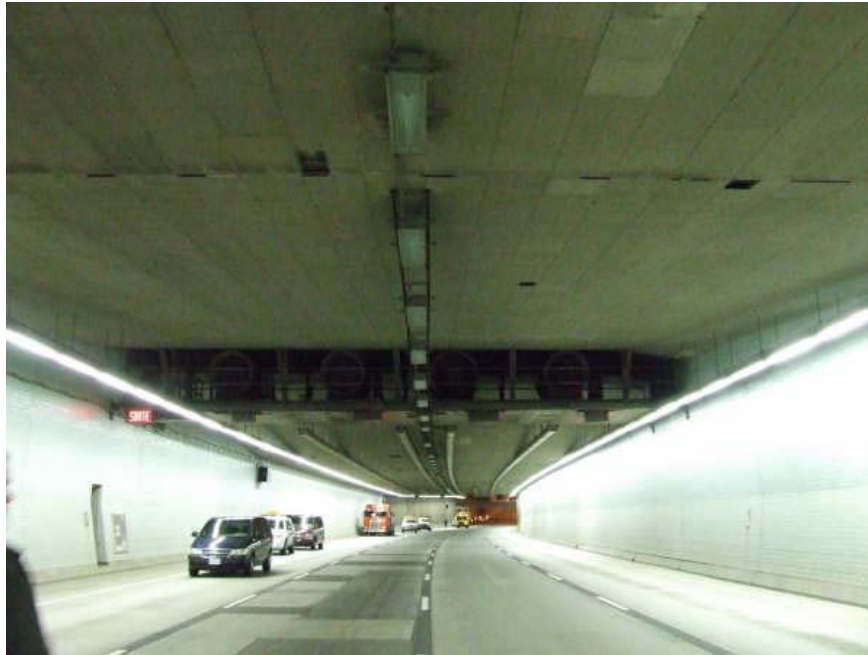
Figure 2.1. Photograph of Tube A of the Carré-Viger Tunnel

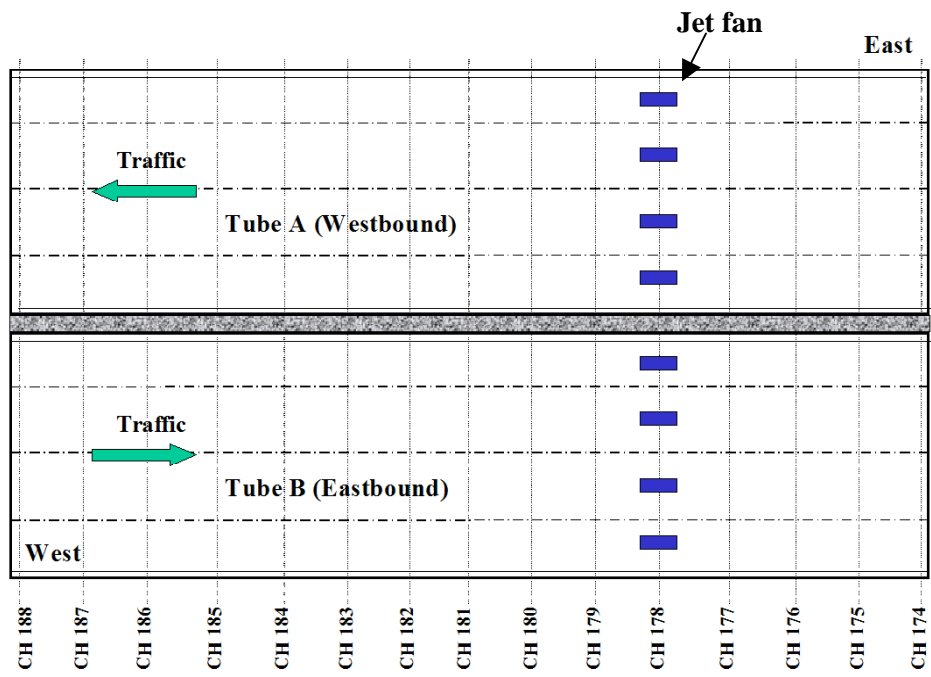
The Carré-Viger Tunnel, completed in 1986, is a part of the A-720 Autoroute Ville-Marie that runs through downtown Montreal. The tunnel is composed of two underground one-way traffic tubes running East to West (Tube A) and West to East (Tube B). Each tube is a 4-lane roadway with a length of approximately 400 m, a width of 16.8 m, and a height of 5.0 m to the tunnel ceiling (as shown in Figures 2.1 and 2.2). Only trucks that do not carry hazardous materials are allowed in the tunnel.

Figure 2.2. Schematic of the Carré-Viger Tunnel

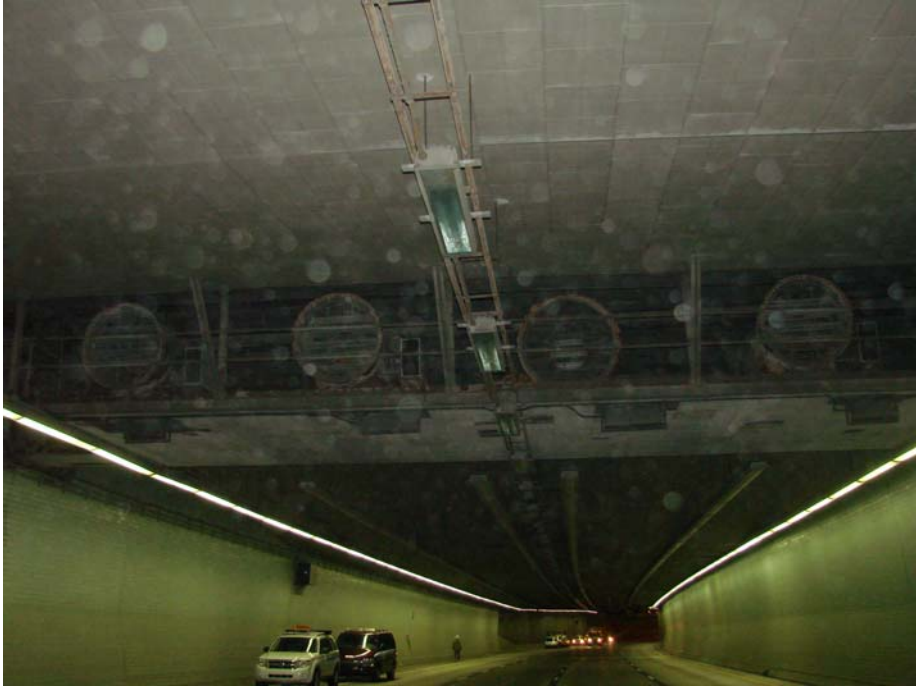
The tunnel has a longitudinal ventilation system that is equipped with eight ceiling jet fans (4 fans in each tube). The jet fan system in Tube A of the tunnel is shown in Figure 2.3. The capacity of each jet fan is 23.6 and 14.2 m<sup>3</sup>/s in the supply and exhaust modes, respectively. Each jet fan can operate on its own or in combination with other fans. The ventilation flows can be adjusted as needed.

**Figure 2.3. Jet fan system in Tube A of the Carré-Viger Tunnel**

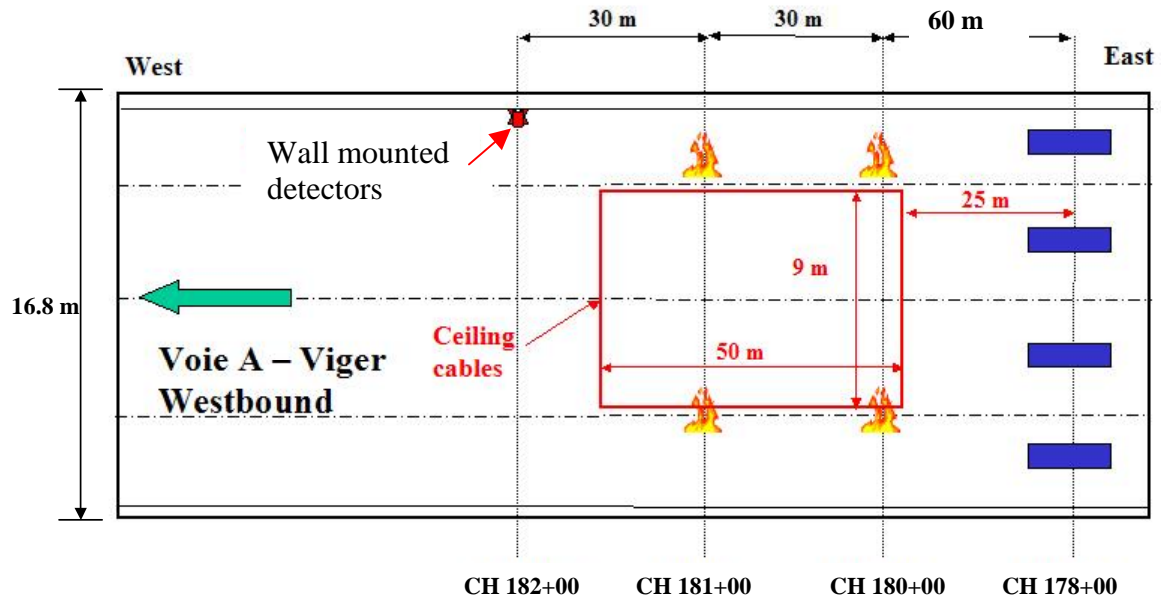
Two linear heat detection systems were installed on the ceiling of the tunnel. These systems would respond to a fire if the rate of temperature rise or the temperature at the cables meets the detection criteria. A schematic showing the setup of the detectors/detection systems in the tunnel is shown in Figure 3.1.

The fire detection capability and coverage area of the flame and VID systems were evaluated at their maximum detection distance by locating the fires 30 m and 60 m from the detectors as well as on both sides of the tunnel (Figure 3.1).

Figure 3.1. Schematic of detector/detection system setup in the tunnel

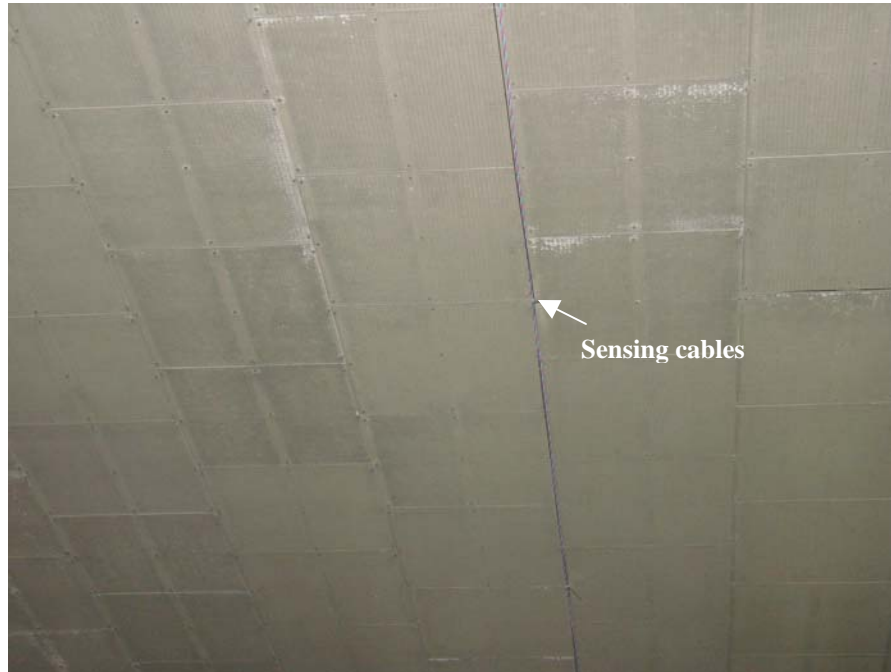
**Figure 3.2. Photograph of linear heat detection systems**

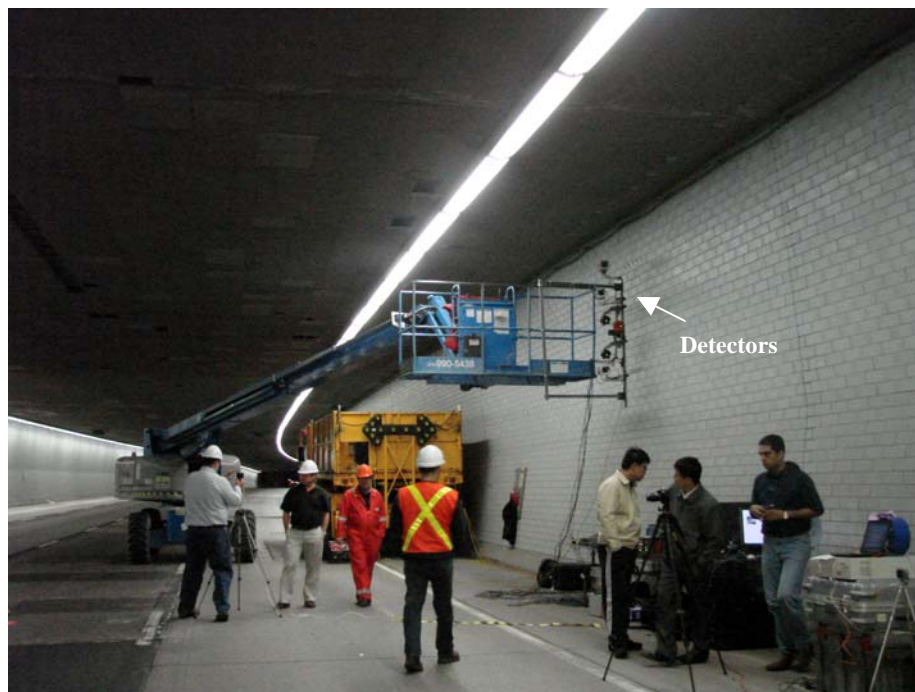
**Figure 3.3. Photograph of detector setup in the test tunnel**

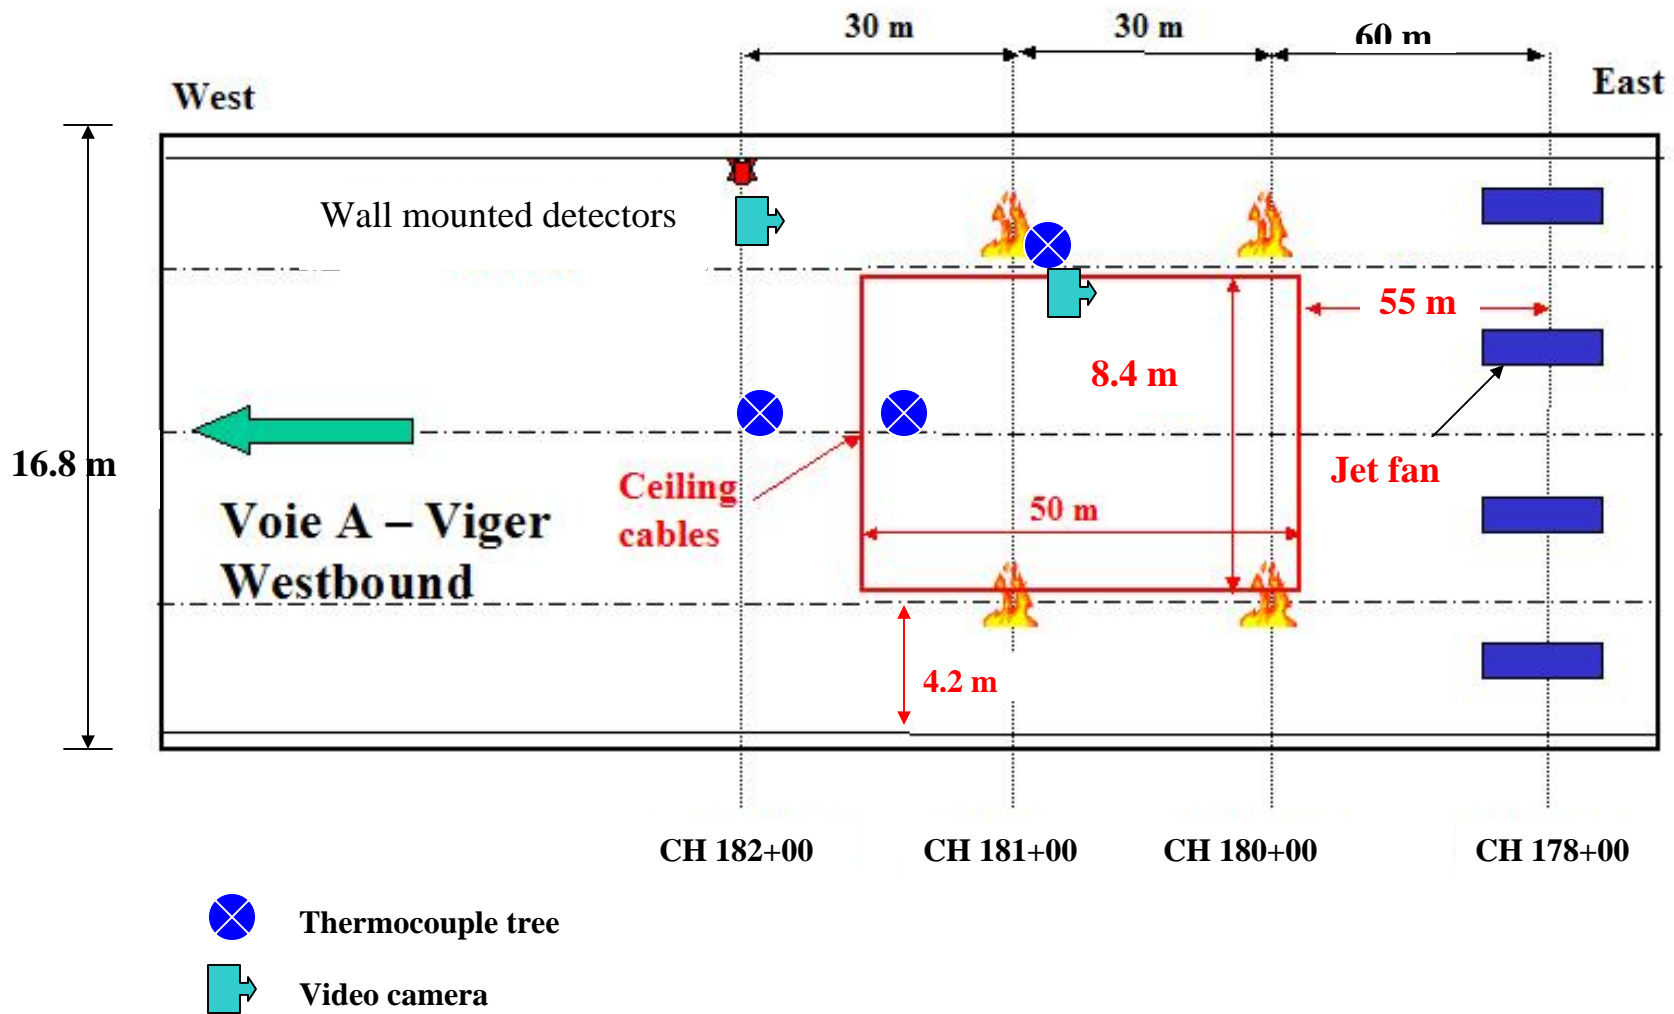
Four data acquisition systems were used in the tests. There was one system for each thermocouple tree used to collect temperature and smoke data. One system was located near the fire detectors/detection systems and was used to monitor the response of the detectors/detection systems to the fires. The test data were collected at one second time interval.

Figure 4.1. Schematic of instrumentation in the tunnel

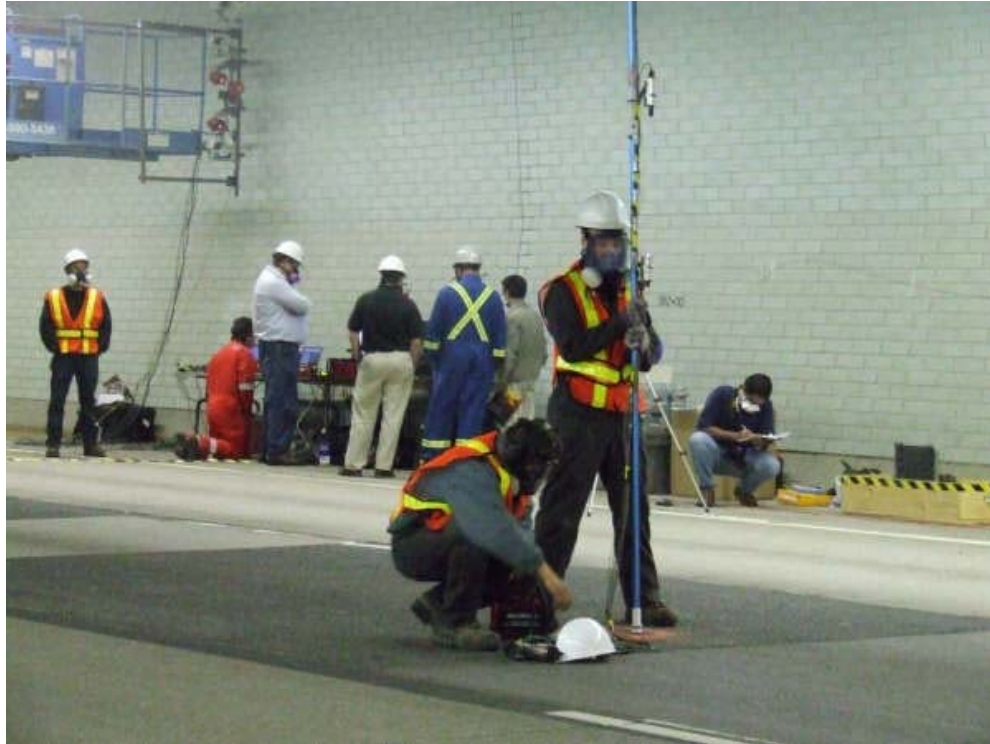
Figure 4.2. Photograph of a thermocouple tree

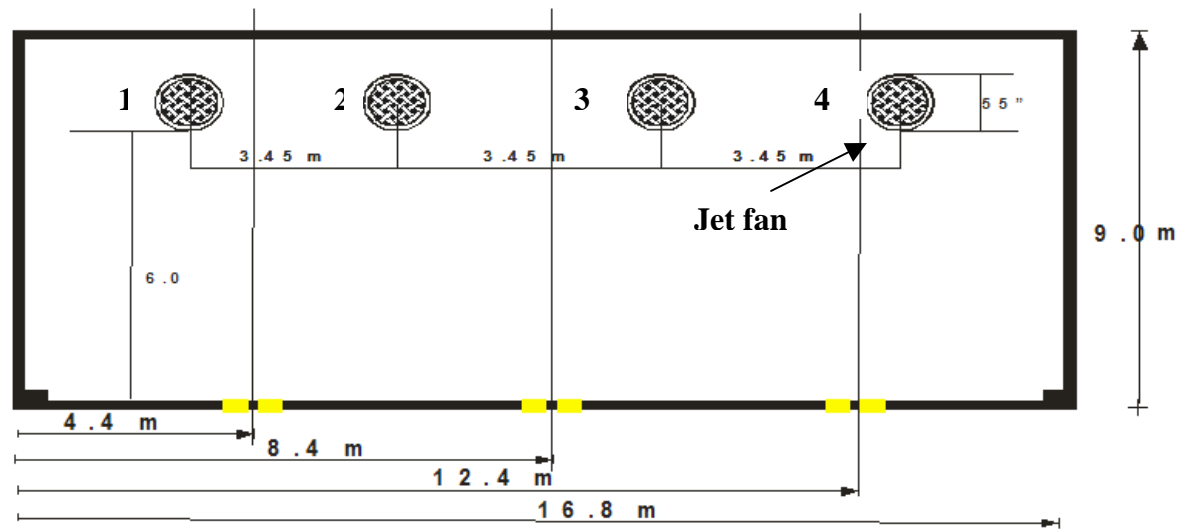
Figure 6.1a. Jet Fan Systems in Viger Tunnel

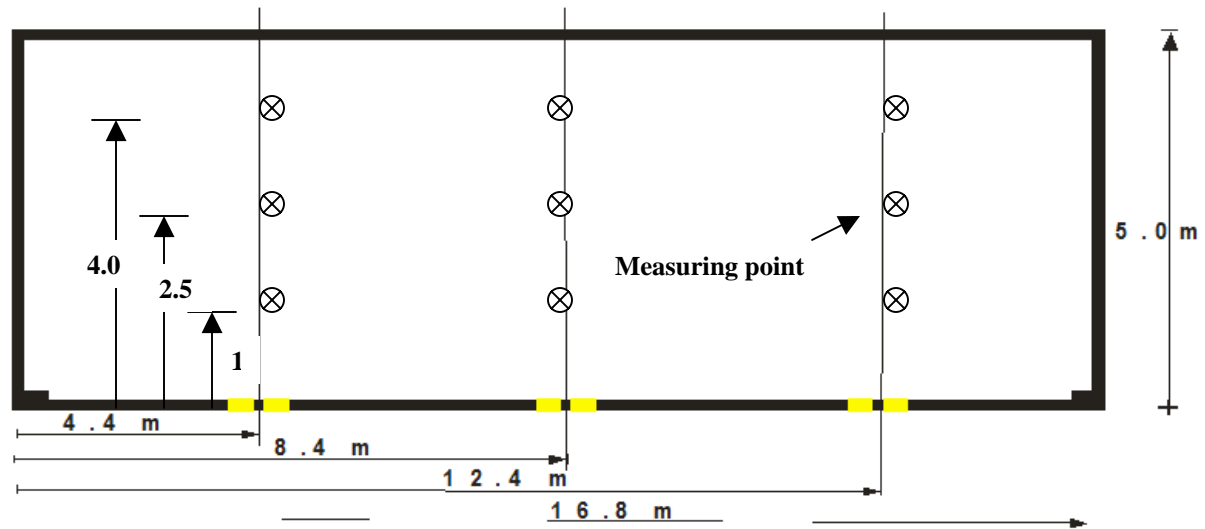
Air velocity measurements were conducted at a number of cross sections of the tunnel, including the section where the fire was located using a velocity meter. Measurements were taken prior to and during the tests (Figure 6.2). The measurement locations were 60 m, 90 m, 150 m and 210 m from the fans. The velocities were measured at 9 points at each location. As shown in Figure 6.1b, points 1, 2 and 3 were located 4.4 m from the North wall of the tunnel and 1 m, 2.5 m and 4 m above the ground, respectively. Points 4, 5 and 6 were located 8.4 m from the North wall of the tunnel and 1 m, 2.5 m and 4 m above the ground, respectively. Points 7, 8 and 9 were located at 12.4 m from the North wall of the tunnel and 1 m, 2.5 m and 4 m above the ground, respectively.

Figure 6.1b. Velocity measuring points in Viger Tunnel

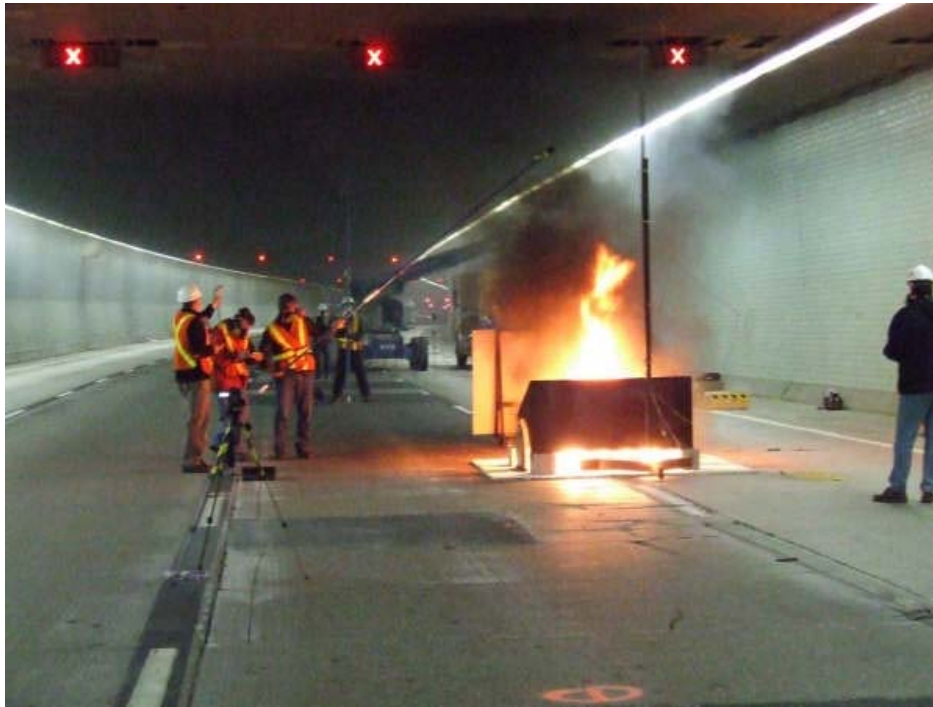
Figure 6.2. Measurement of air velocity at fire location during test

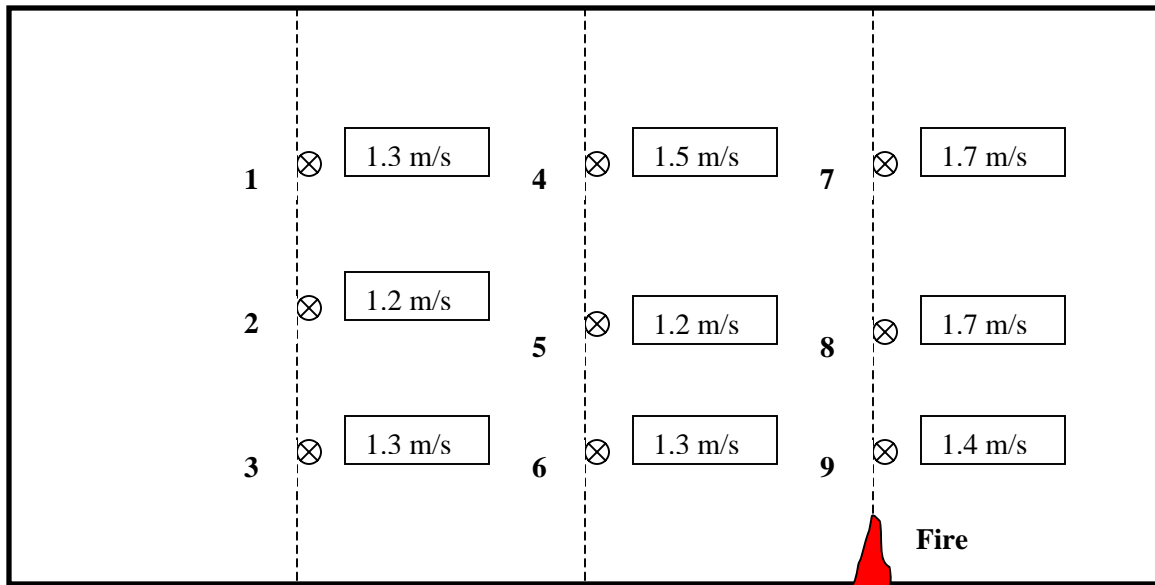
Test results showed that air velocities were more uniform with an increase in distance from the fan systems. The air velocity near the fire source was affected by the setup around the fire, such as the size and location of obstacles. Figure 6.3 shows the air velocities measured at the section where the fire was located (32 m from the detectors) for Test F-3 using Jet Fan #3. The average air velocity was 1.3 m/s. The average airflow velocities produced with two and three jet fans were 2 m/s and 2.4 m/s, respectively.

Figure 6.3. Airflow velocity at fire location in Test F-3

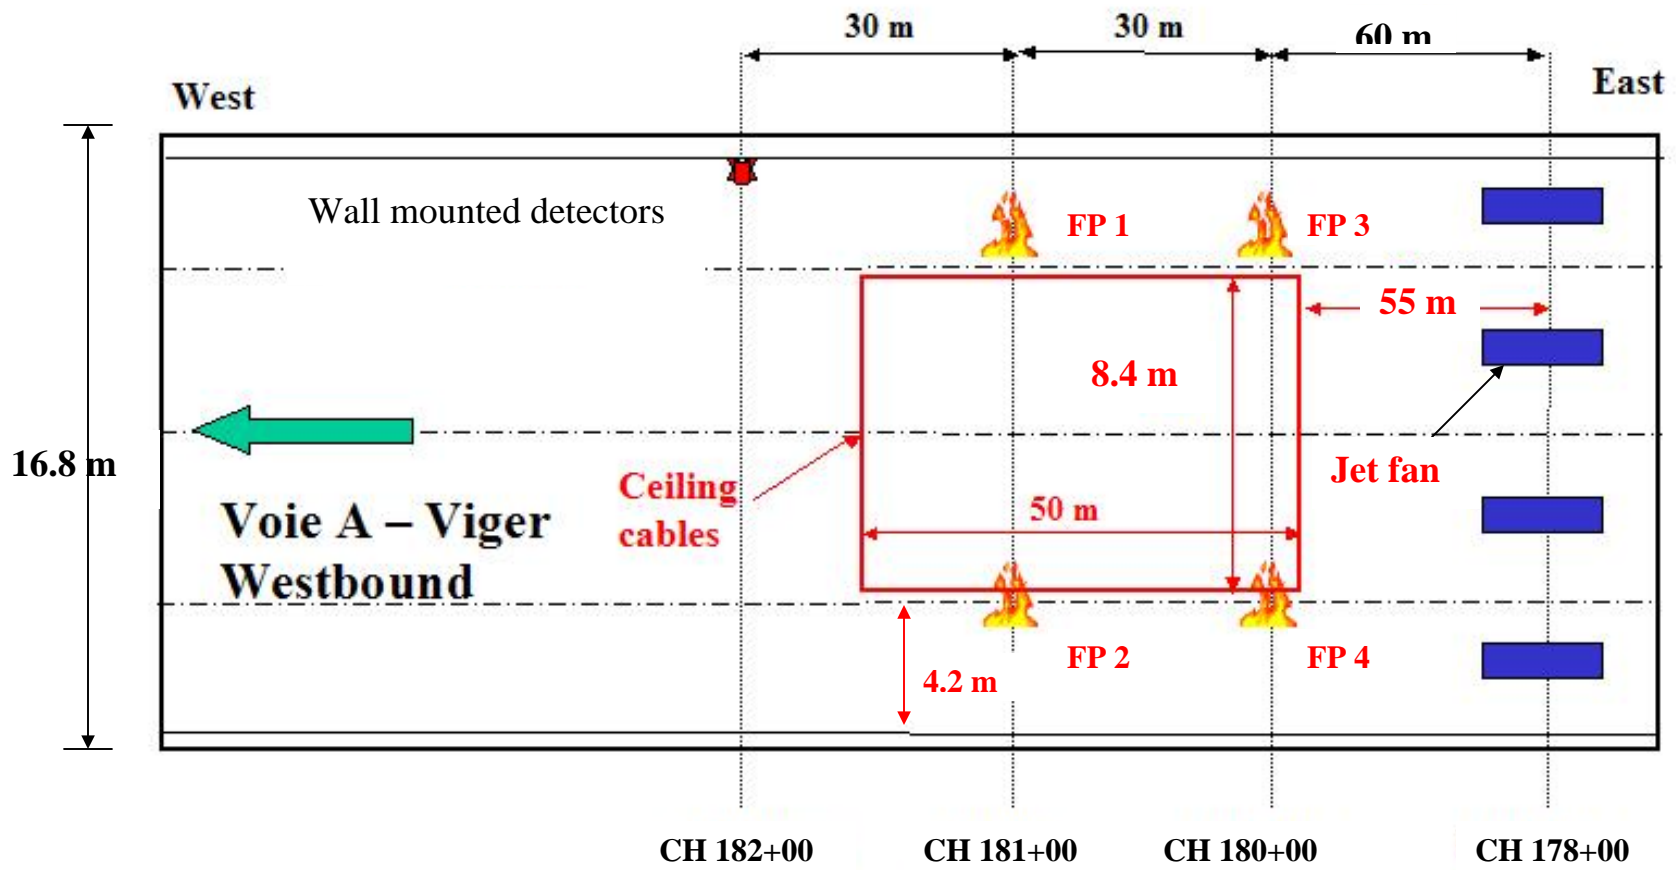
Figure 7.1. Schematic of fire locations in the test tunnel

Four full-scale tests were conducted with a 0.3 m by 0.3 m gasoline pool fire (Tests F-1, F-5, F-7 and F-9). The fire (Figure 7.1) was placed at four locations in the tunnel. There was no obstacle around the fire source. Ambient temperature in the tunnel was 18°C with no prevailing wind. All tests were conducted with minimal airflow velocity in the tunnel (approximately 0 m/s). The tests were designed to study the response of the detectors/detection systems to a small open pool fire. The test conditions and results for the open pool fire are listed in Table 7.1.

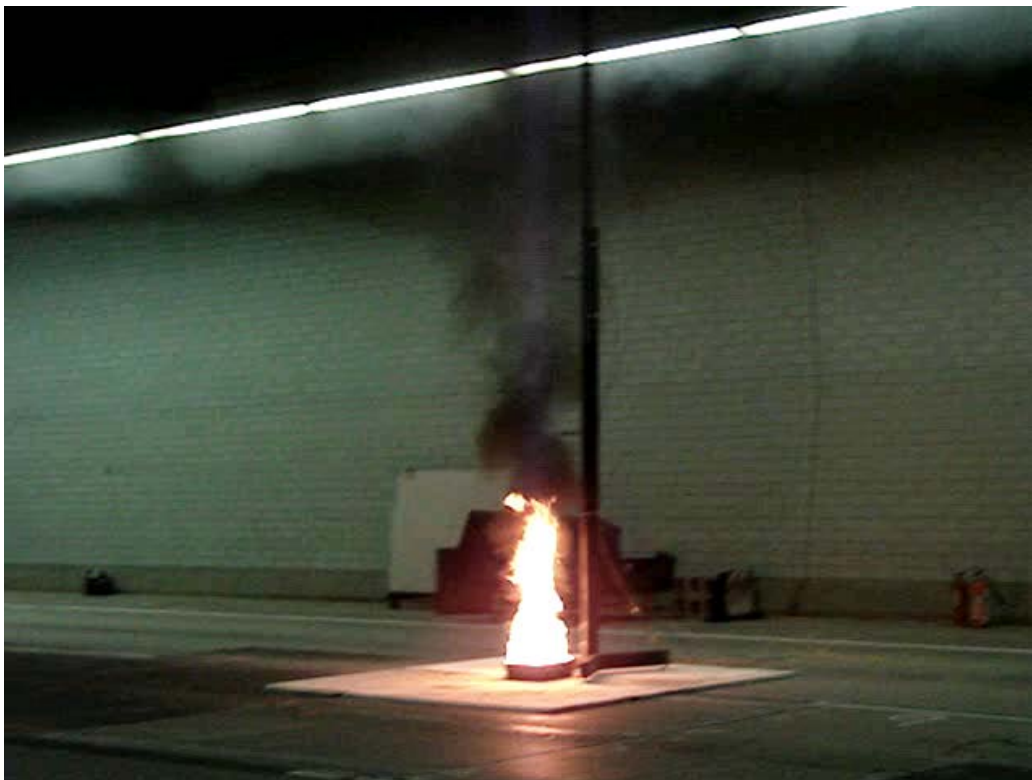
The fire was allowed to burn freely for approximately 9 minutes until the gasoline in the pan was consumed. The fire developed very quickly and substantial smoke was produced and accumulated below the ceiling (Figure 7.2). The smoke did not obstruct the view of the detectors during the tests. The maximum heat release rate produced by the fire was approximately 125 kW.

Figure 7.2. Photograph of a small open pool fire in Viger Tunnel tests

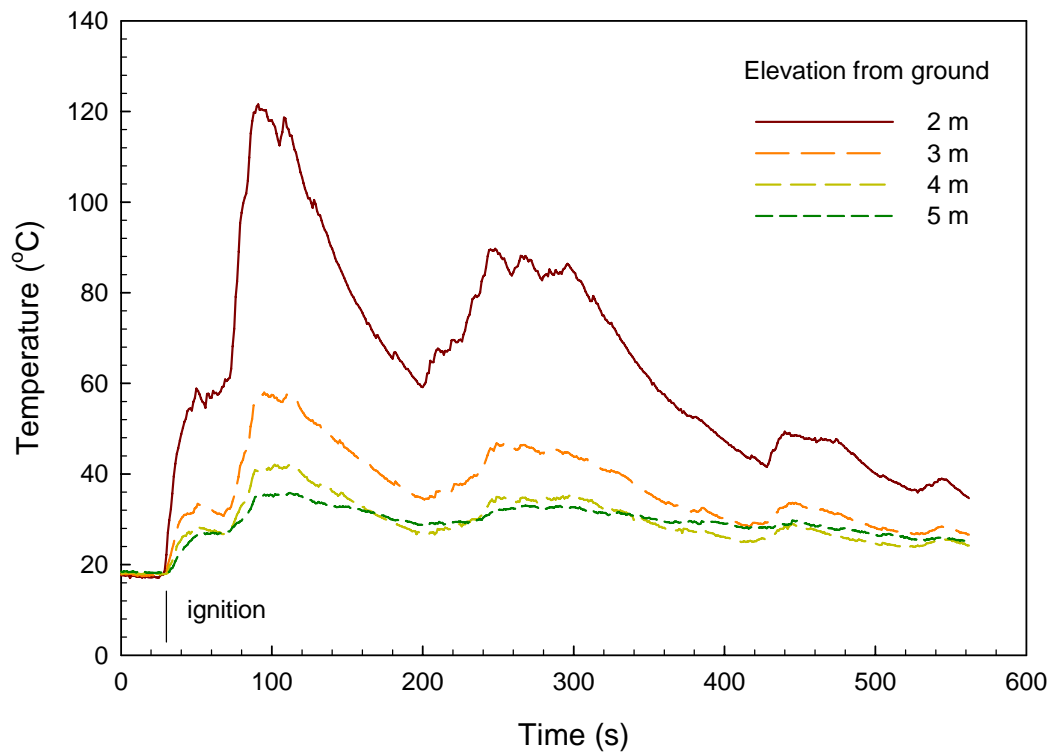
Figure 7.3 shows the variation in temperature with time in Test F-1 when the fire was located at FP 1. The temperatures were measured at thermocouple tree #1 near the fire source. The temperature was approximately 120°C near the tip of the fire plume and it quickly decreased with an increase in elevation. The maximum temperature near the ceiling of the tunnel was approximately 33°C. The rate of rise of temperature at the ceiling was approximately 15°C/min.

Figure 7.3. Temperatures at Thermocouple Tree #1 in Test F-1

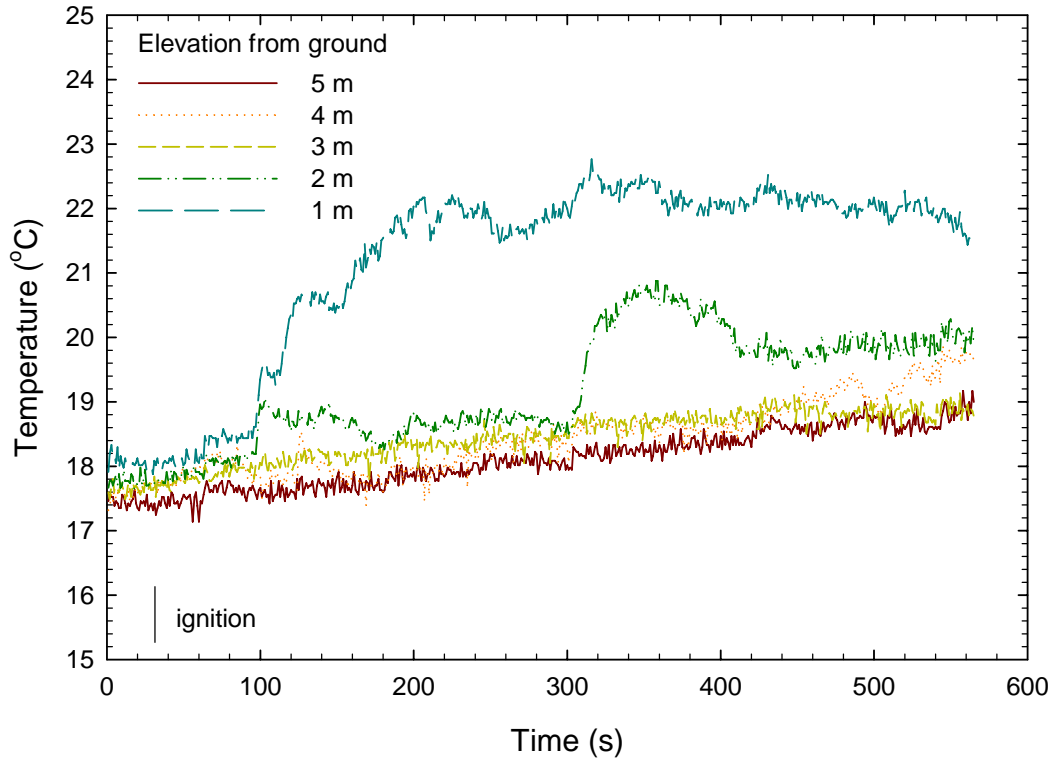
Figure 7.4 shows the temperatures measured at thermocouple tree #2, 15 m from the fire source in Test F-1. The temperature started to increase approximately 70 s after the ignition of the fire. The temperature increase near the ceiling was approximately 4°C. There was a minimal increase in temperature at heights less than 4 m.

Figure 7.4. Temperatures measured at Thermocouple Tree #2 15 m from fire location in Test F-1

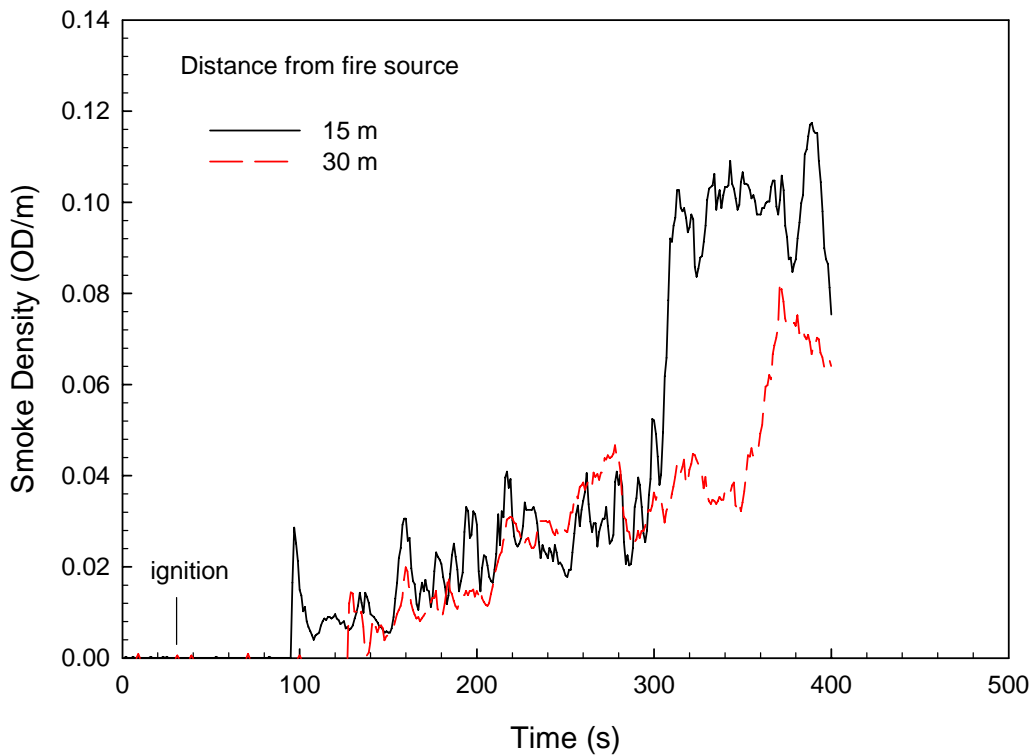
The smoke production and spread in Test F-1 are shown in Figure 7.5. The smoke optical densities (OD/m) near the ceiling were measured 15 m and 30 m from the fire location. The smoke optical density increased with time and had a significant increase when the fire reached a certain level. The smoke optical density at 15 m from the fire source was higher than that at 30 m. This suggests the smoke was diluted as it moved down the tunnel. The smoke spread in the tunnel can be calculated from the time interval from ignition and the distance between the measuring point and the fire location. Since the optical smoke density produced by the small pool fire was limited, the VID systems were able to monitor the fire conditions in the tunnel throughout the tests.

Figure 7.5. Smoke optical density at ceiling, 15 m and 30 m from fire location in Test F-1

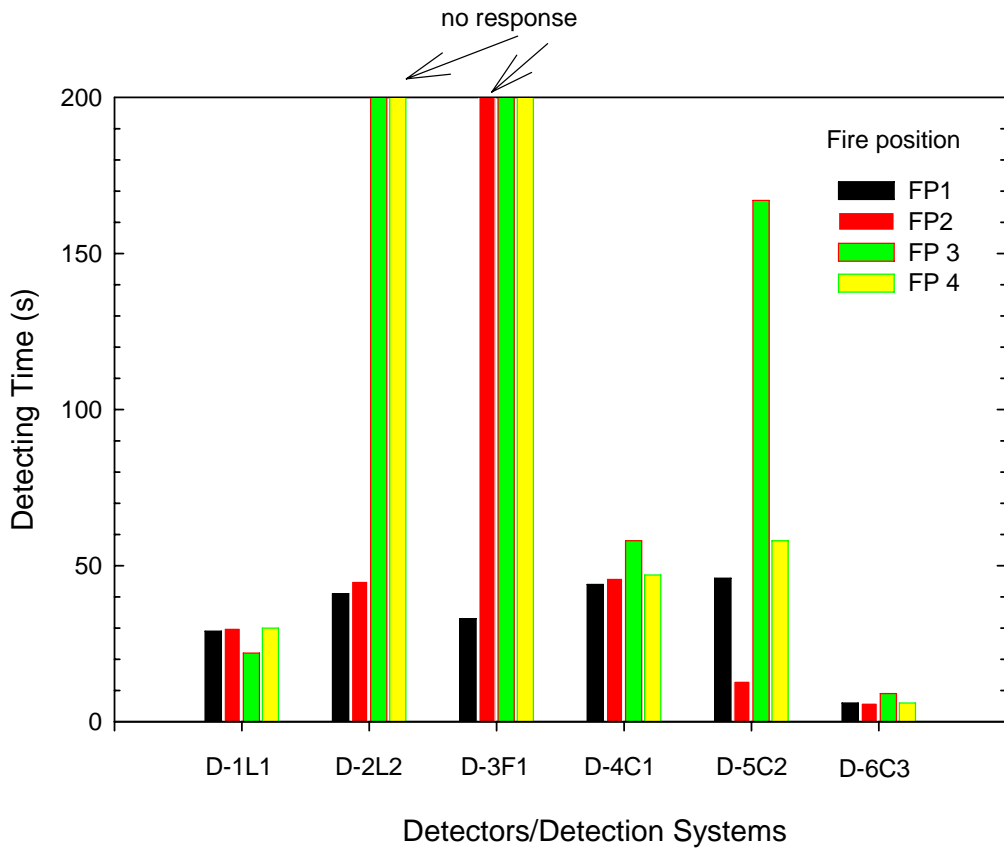
The flame/smoke VID system D-5C2 also responded to all the fires with the response times ranging from 13 s to 167 s. The performance of the detector was affected by the change in fire location.

The flame VID system D-6C3 detected the fires located at FP #1 to FP #3 in the tunnel with the detection time ranging from 6 s to 9 s. It detected the fire at position FP #4, after the view of the detector was adjusted. The performance in the operating tunnel was consistent with that in the laboratory tunnel tests with the same fire setup [1].

Figure 7.6. Response times of fire detectors/detection systems to a 0.09 m<sup>2</sup> open fire

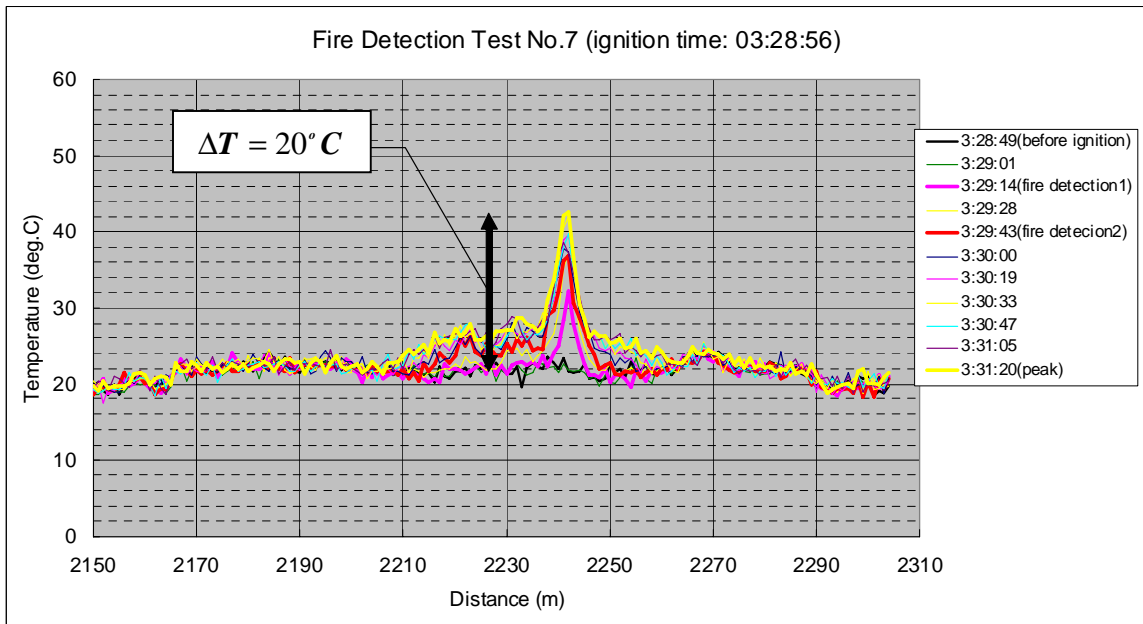
Figure 7.7. Variations of temperatures along linear heat detection system D-1L1 in Test F-7

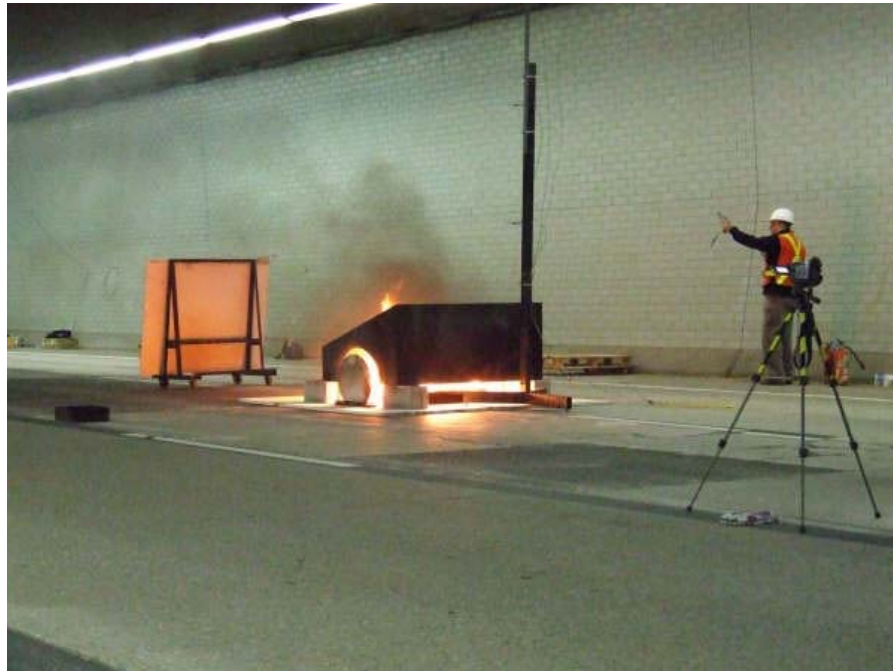
Three tests with a 0.36 m<sup>2</sup> gasoline pool fire located underneath a simulated vehicle (Tests F-2 to F-4) were conducted in the Viger Tunnel. The setup of the fire scenario was the same as used in the laboratory tunnel tests of the project [1, 2]. The fuel pan was placed underneath a simulated vehicle. A 1.5 m wide by 1.2 m high plate, simulating a crashed car, was located between the fire source and the wall-mounted detectors. It was placed 1.5 m in front of the fire source and 0.3 m above the ground. The heat release rate of the fire was approximately 650 kW when measured using a calorimeter. The setup of the fire scenario in the Viger Tunnel is shown in Figure 7.8.

The fire source was at FP #1 in the three tests: 32 m from the detectors mounted on the wall and 4.8 m from the North wall of the tunnel. Three tests with the same fire setup were conducted with the average airflow velocities in the tunnel at 1.3 m/s, 2.0 m/s and 2.4 m/s. The tests were used to study the impact of airflow on the response of the detectors/detection systems to a small fire located underneath a vehicle. The test conditions and results for the pool fire located underneath the vehicle are listed in Table 7.2.

Figure 7.8. Photograph of a pool fire located underneath a vehicle in Viger Tunnel tests

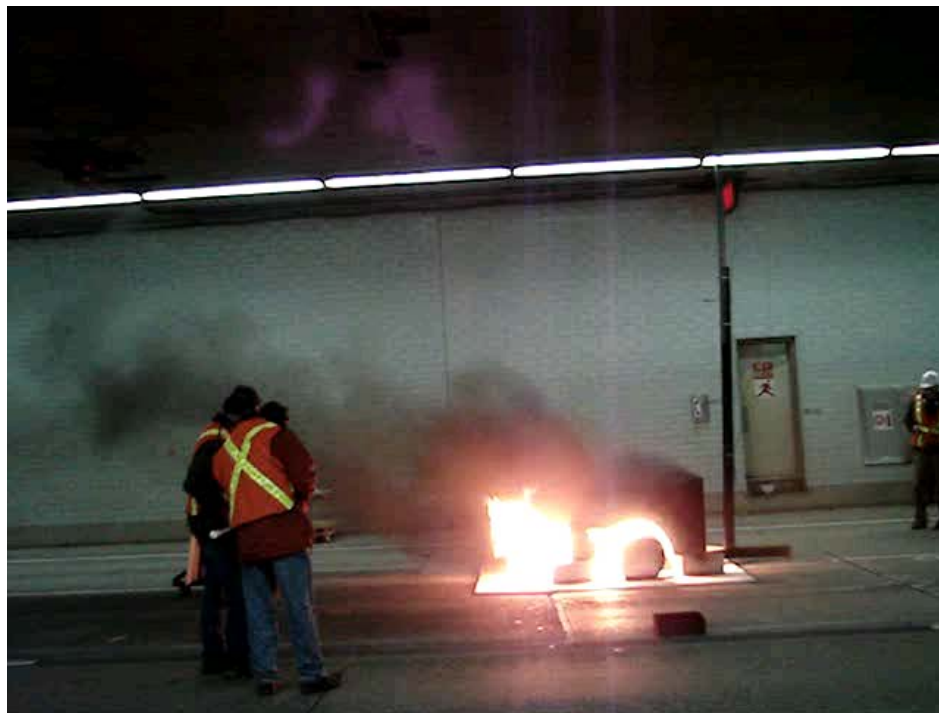
Ambient temperature in the tunnel was 18°C. The fire was allowed to burn freely until the gasoline in the pan was consumed. The fire plume was tilted by the longitudinal airflow. The angle of the fire plume to the ground was reduced with an increase in airflow speed. Moreover, the fire plume became short and unsteady at high airflow speed, as shown in Figure 7.9. The plate placed in front of the fire obstructed the view of the detectors mounted on the wall and partially shielded the flames. Figure 7.10 is a photograph taken from the front of the fire setup.

Figure 7.9. Side view of a 0.36 m<sup>2</sup> gasoline pool fire located underneath a vehicle

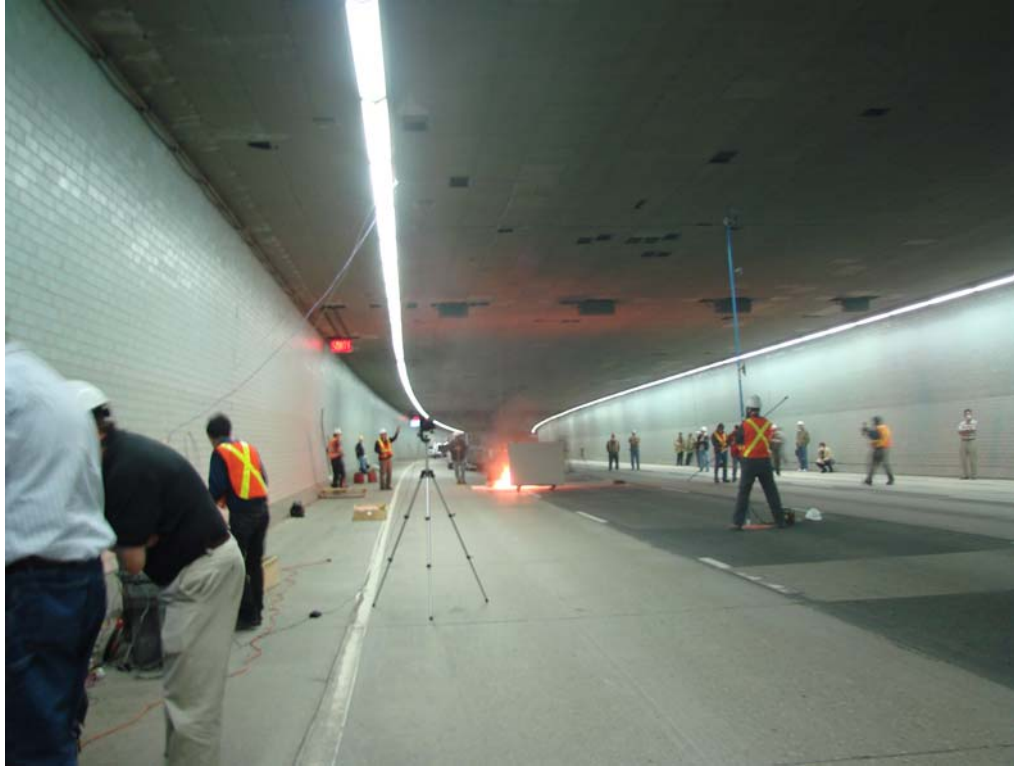
**Figure 7.10. Front view of a 0.36 m<sup>2</sup> gasoline pool fire located underneath a vehicle**

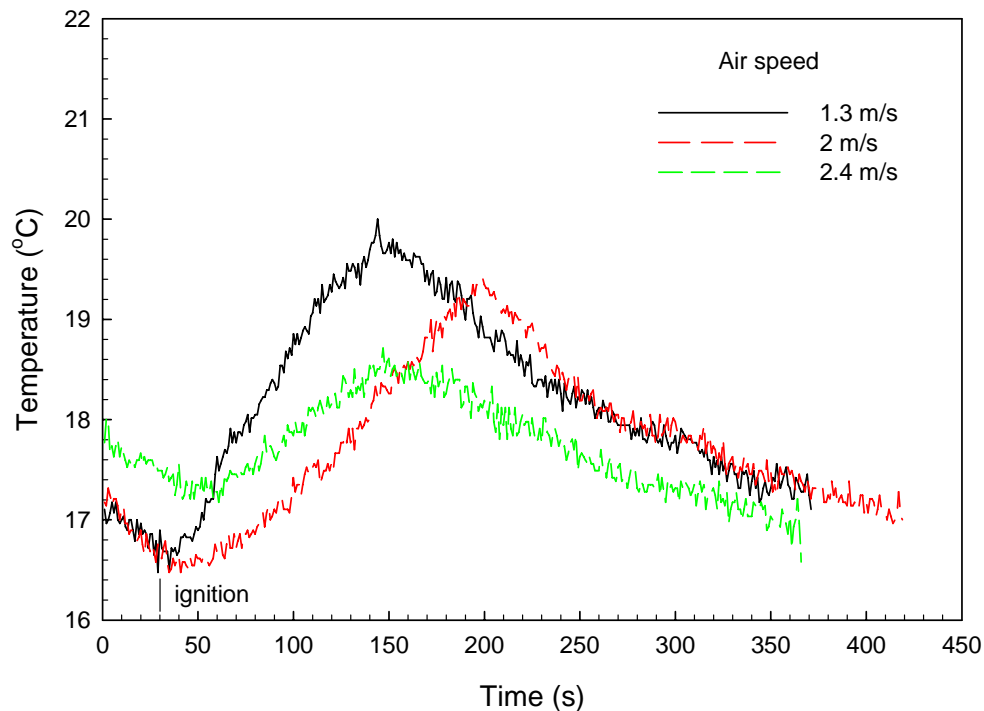
Figure 7.11 shows the ceiling temperatures in the tests with variation in airflow velocity. The temperatures were measured near the fire source. The ceiling temperatures near the fire had a minimal increase as the fire plume was tilted towards the downstream side of the fire. The temperature decreased with an increase in air velocity. The maximum ceiling temperature ranged from 18°C to 20°C.

Figure 7.11. Ceiling temperatures at the fire location in Viger Tunnel tests

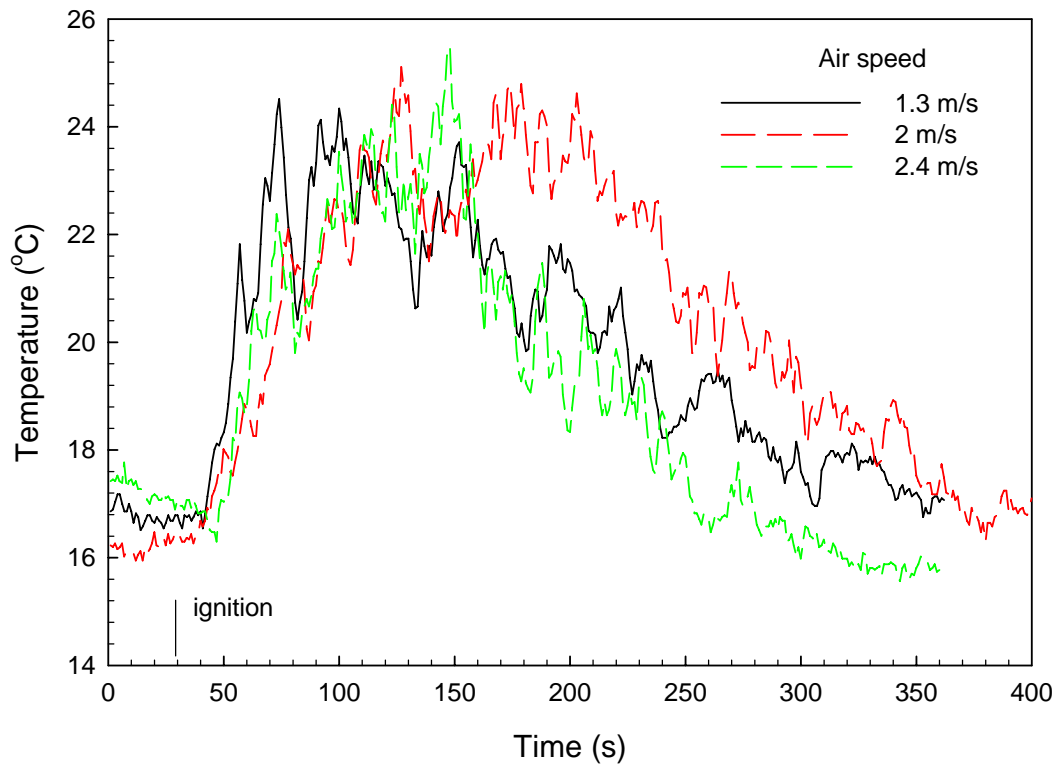
Figure 7.12 shows the ceiling temperatures measured 15 m downstream of the fire source. The ceiling temperatures were higher than those near the fire source. The temperature did not change with airflow speed. The maximum ceiling temperature was approximately 25°C.

Figure 7.12. Ceiling temperature measured at 15 m downstream of the fire

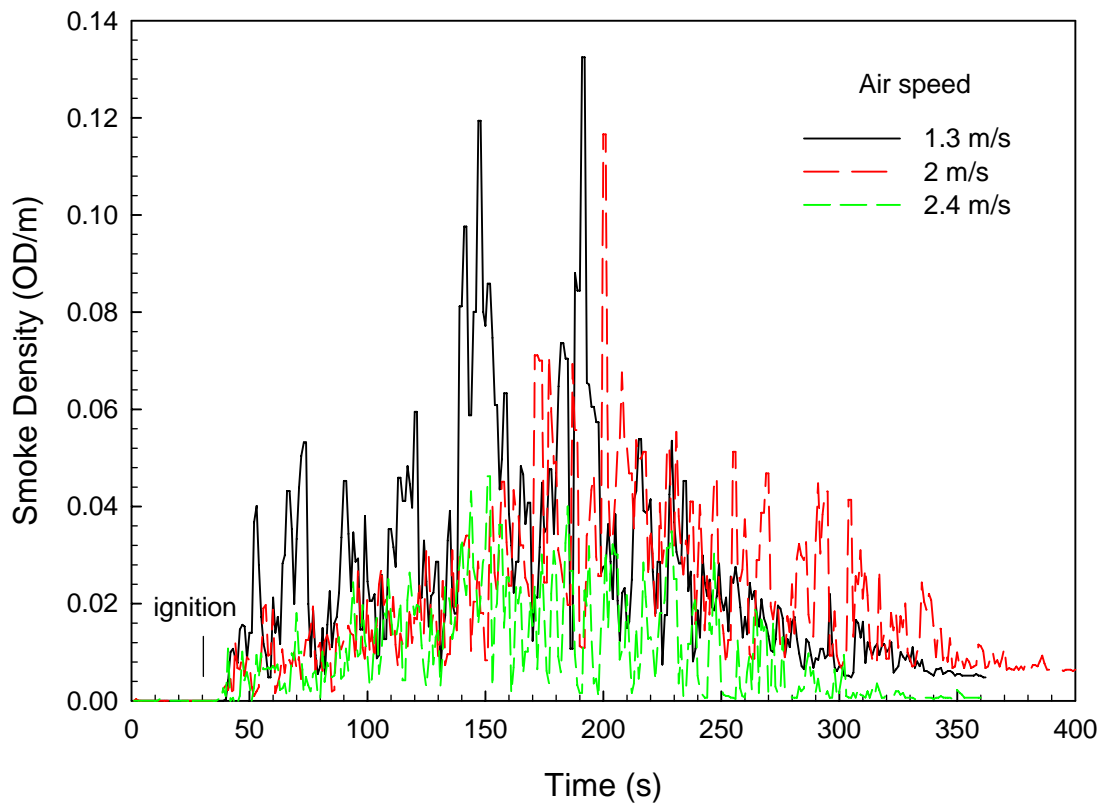
Figure 7.13 shows the variation of the ceiling smoke optical density measured 15 m downstream of the fire source. The smoke optical density measured near the ceiling decreased with an increase in airflow speed. The results also showed that the smoke produced by the fire under airflow conditions was not steady, which was consistent with the visual observations during the tests. The VID systems mounted at the wall of the tunnel were able to monitor the fire conditions in the tunnel throughout the tests.

Figure 7.13. Ceiling smoke optical density measured 15 m downstream of the fire
